From: [Quinones, Edwin](#)
To: [Talton, Chuck](#)
Cc: [Shewmake, Kenneth](#)
Subject: FW: Star Lake Canal Site; SLCCP's Response to BP/Total's CDM Report
Date: Tuesday, December 11, 2018 5:10:05 PM
Attachments: [SLCCP REBUTTAL to BP and Total CDM Report \(Final\).pdf - Adobe Acrobat Pro \(2\).pdf](#)
[BP-TOTAL Letter Figures Complete 9-10-18 11 x17 size.pdf](#)

On behalf of the Star Lake Canal Cooperating Parties (SLCCP), thank you and your team for meeting with us on March 14, 2018. We found the meeting productive and hope you and your team found it informative. As you know, the genesis of that meeting was the presentation developed by CDM Smith Inc. (CDM Smith) on behalf of both Total Petrochemicals & Refining USA, Inc. and BP America Inc. (collectively BP/Total or the Companies). The SLCCP is now in receipt of a written submission to USEPA (CDM Smith Report) that further outlines the position of the Companies. This letter provides the SLCCP's response to CDM's presentation and the CDM Smith Report.

1. Executive Summary

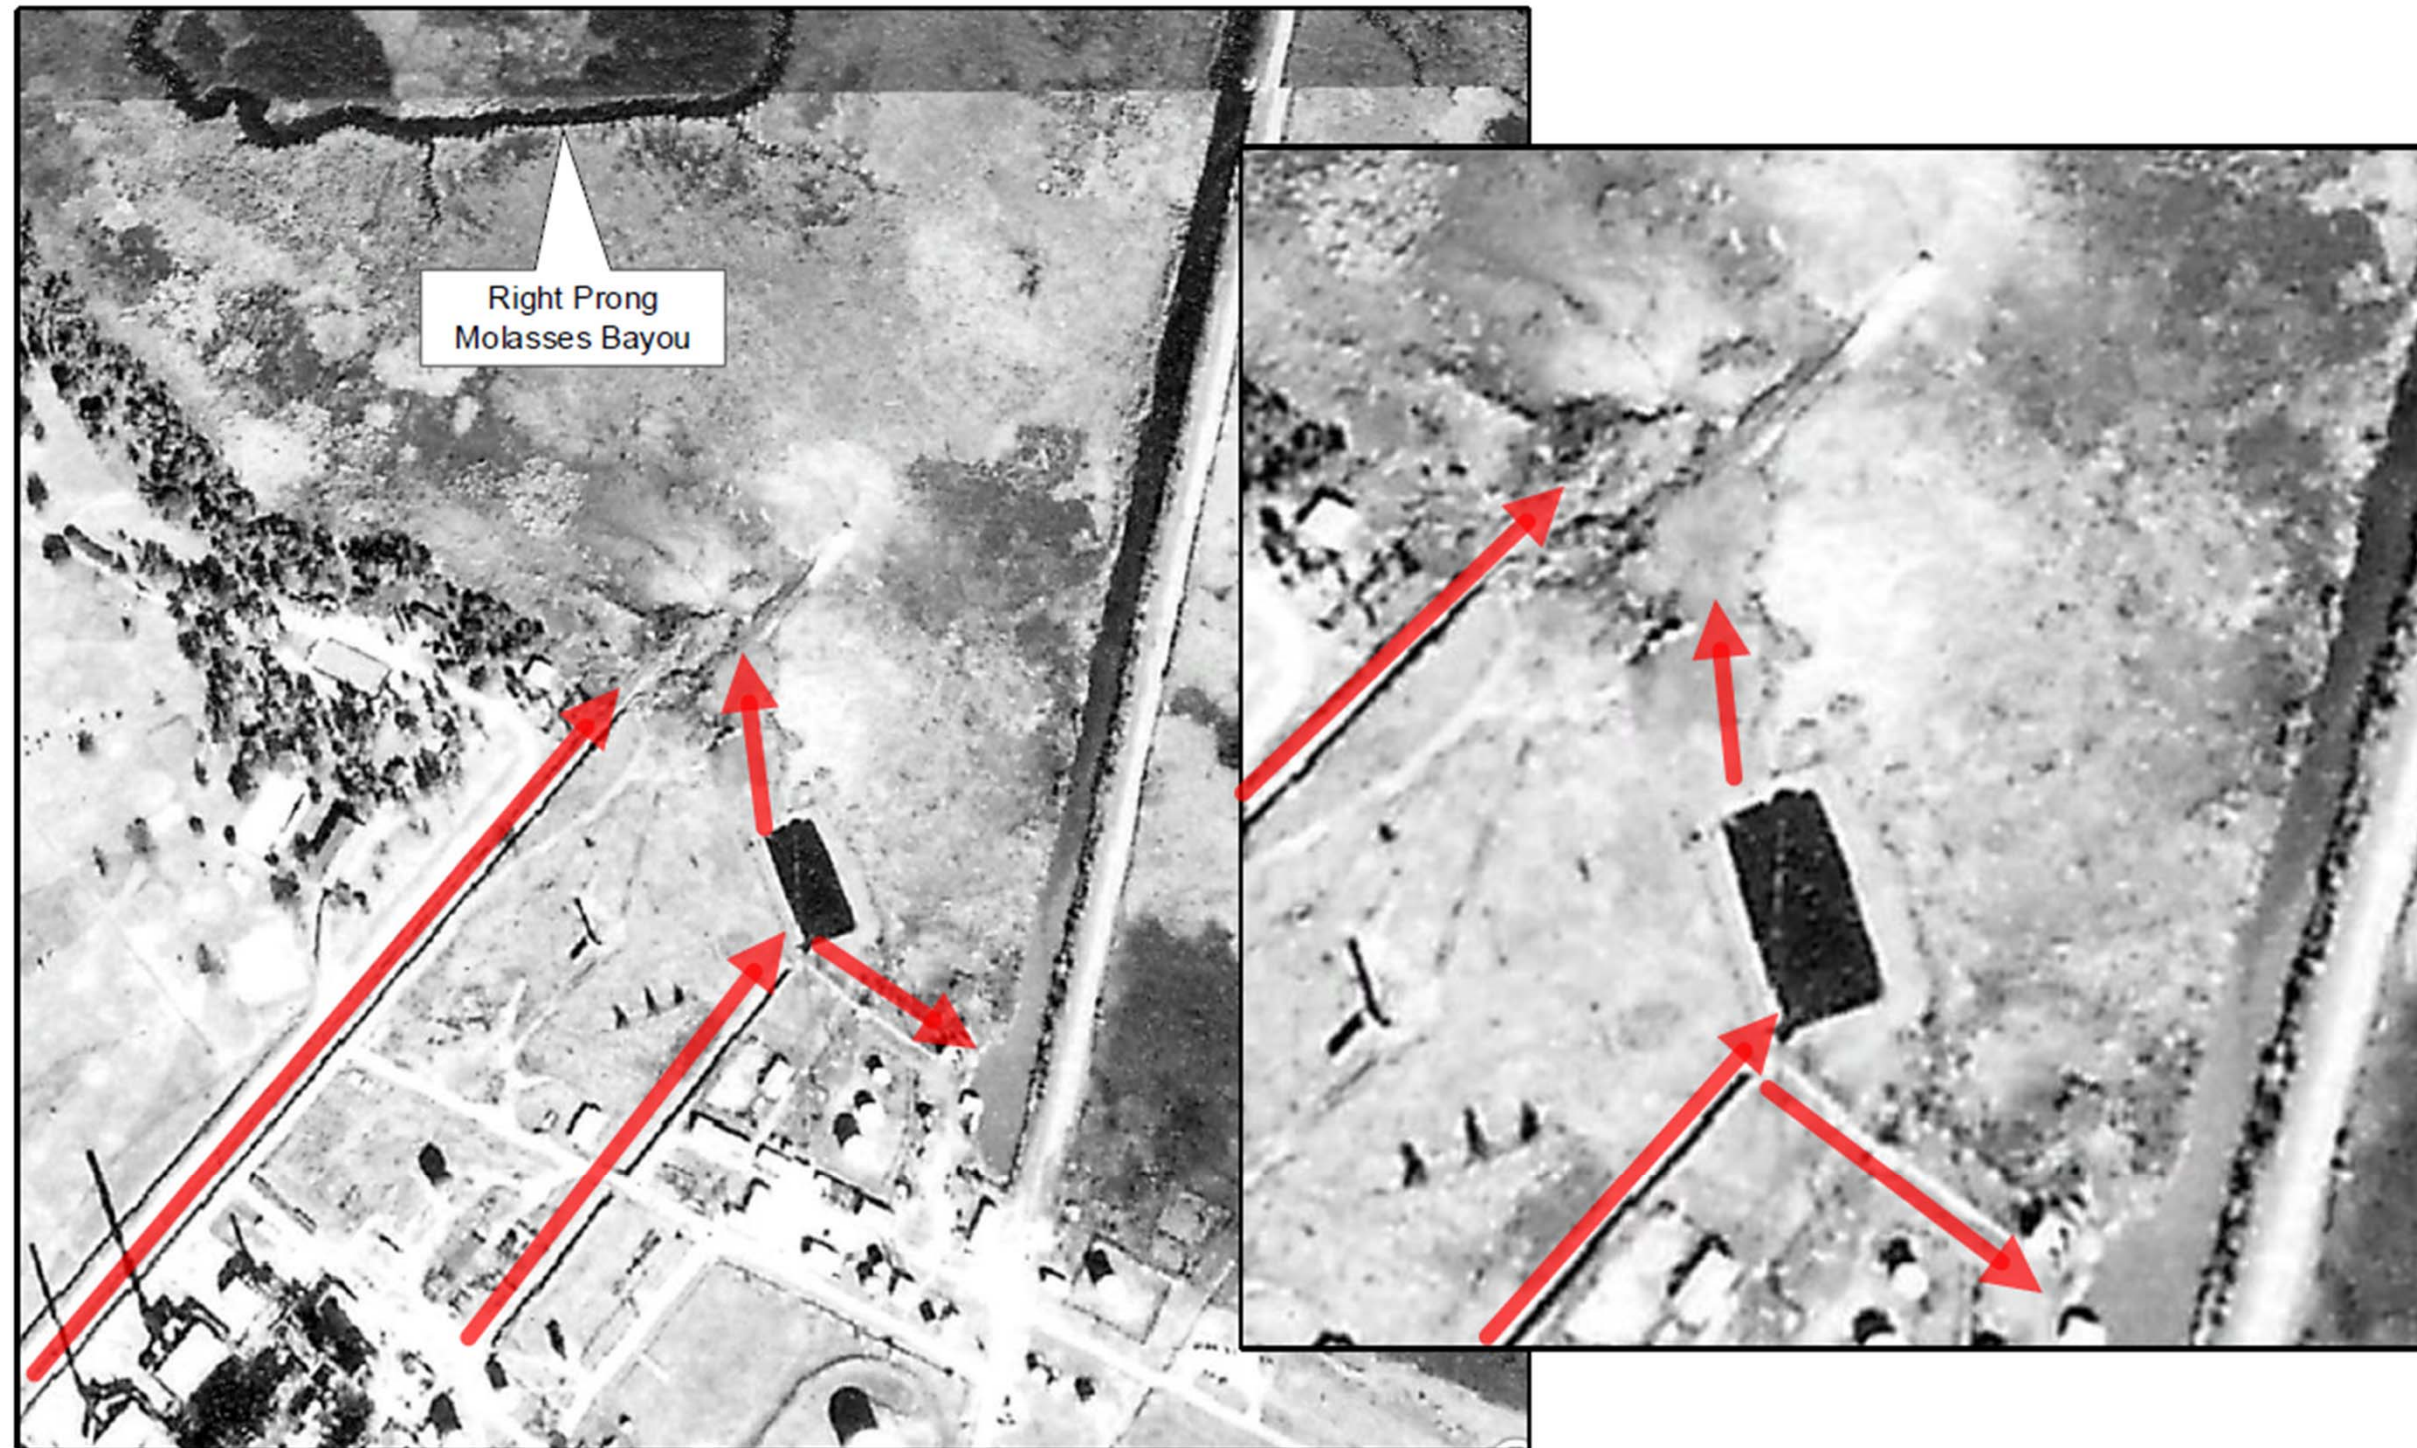
Figure 3: Refinery Discharges Prior to Installation of Separator Canal December 1938 Google Earth

Aerial: Google Earth December 1938

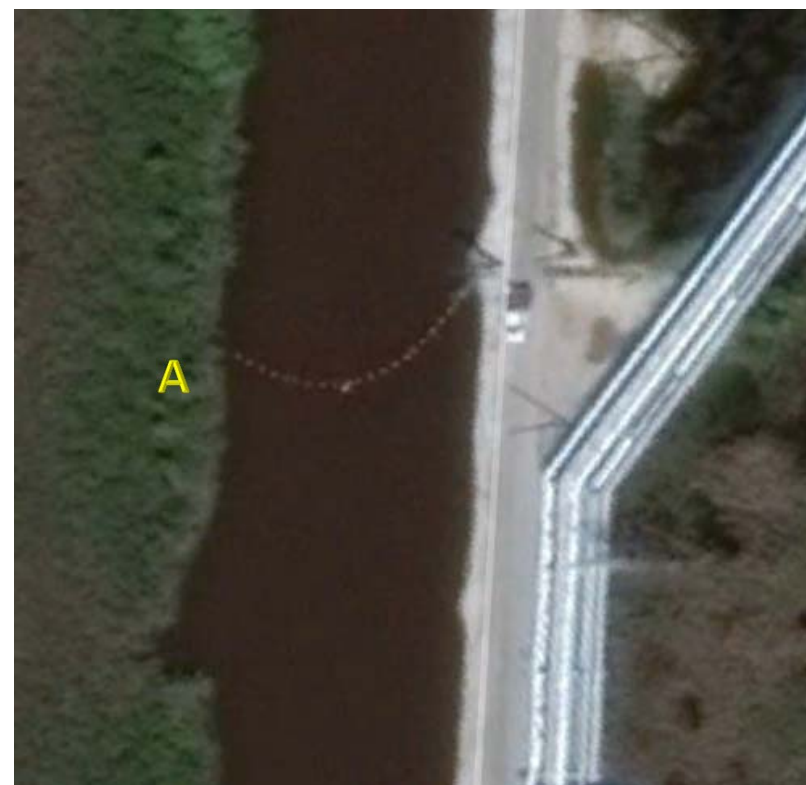
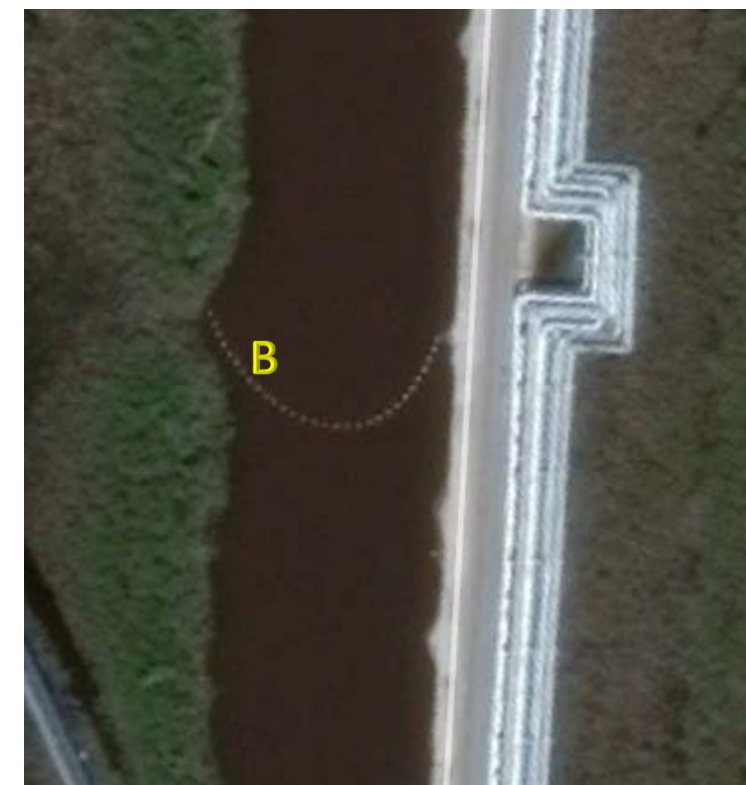
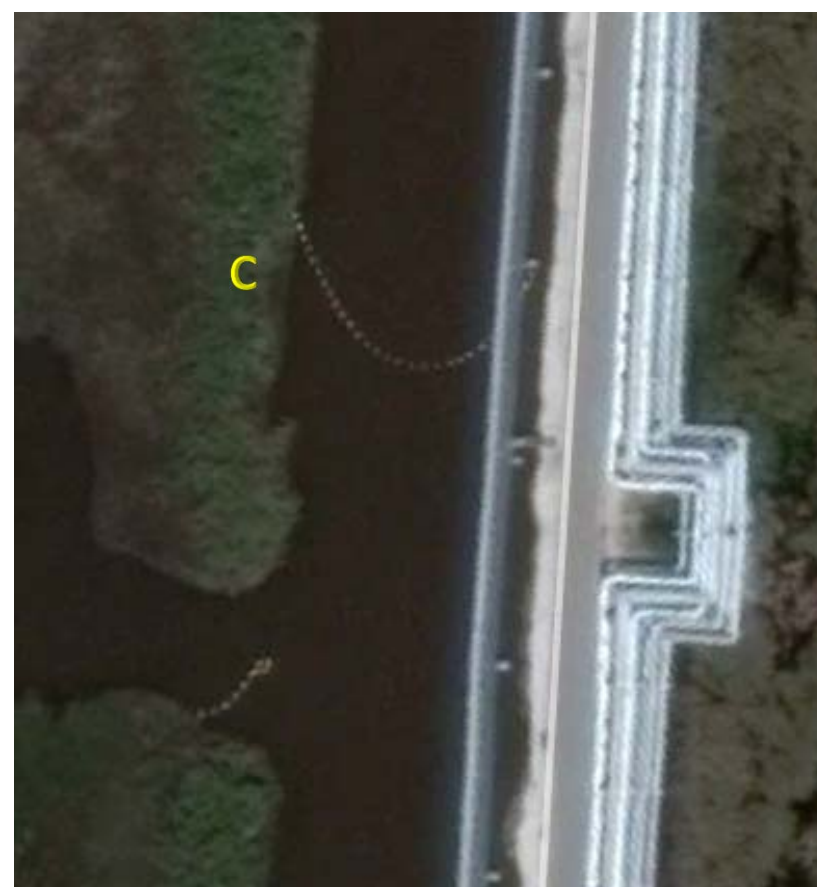
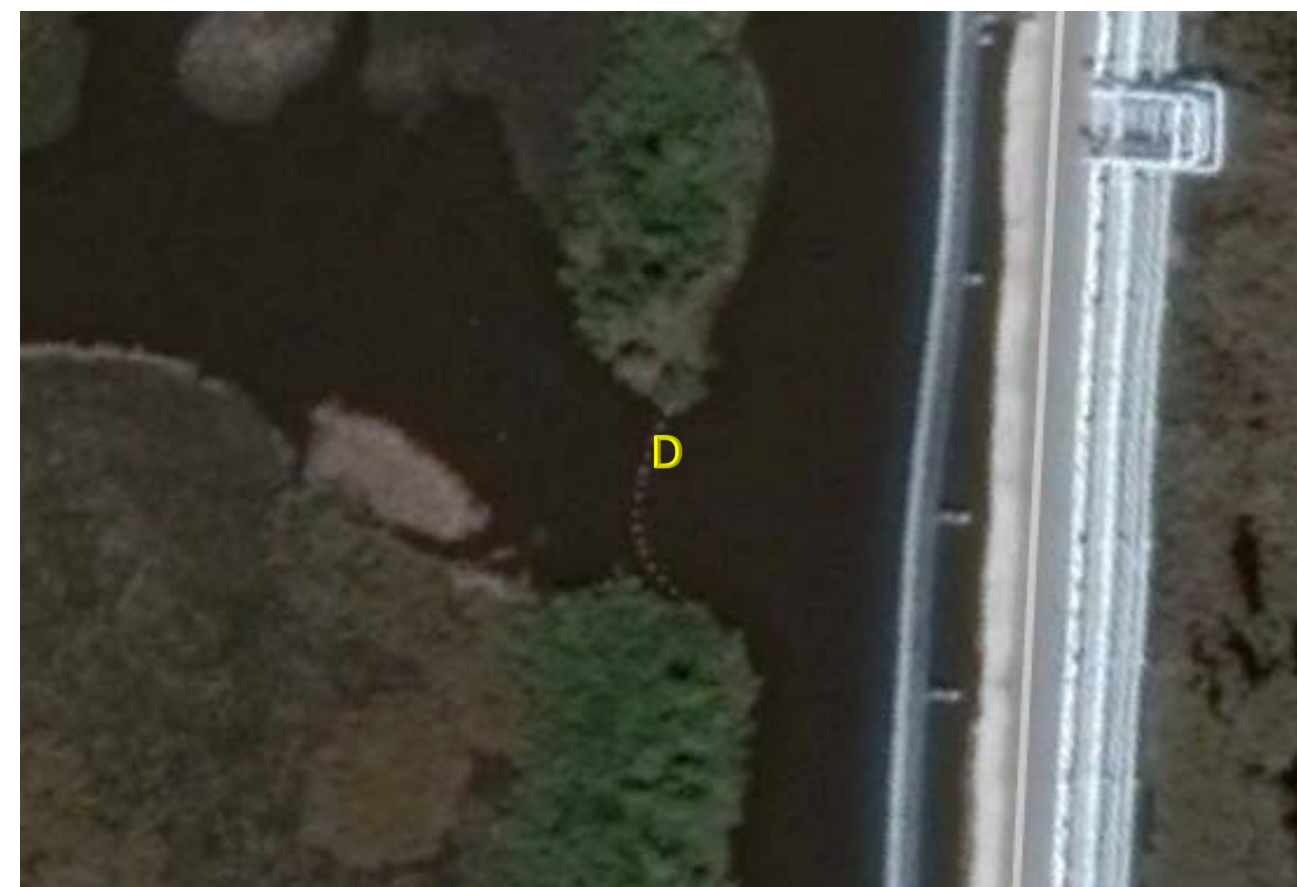
Figure 14: Curvature of Oil Control Booms in the Boat Canal on March 26, 2015

Aerial: March 26, 2015 Google Earth Imagery

Attached Figures 14 and 15 show aerial photographs of the Boat Canal out to the Neches River on March 26, 2015, and January 29, 2017, respectively. Oil control booms are observed across the Boat Canal itself and across the entrance of Right Prong into the Boat Canal. In some photographs, booms are also observed across an inlet entering the marsh on the west bank of the Boat Canal between the Right Prong and the Neches River (see attached Figure 15, label D for location of boom). Based on the boom curvature observed in each photo, the tide is in a state of flood for the March 2015 aerial image (attached Figure 14) and in a state of ebb for the January 2017 aerial image (attached Figure 15). This is confirmed by examination of the tidal record on that date as seen in Table 1 above. For the five occasions where the boom orientation and the tide position were compared, there was agreement between the tidal current direction (ebb or flood) and the orientation of the booms.

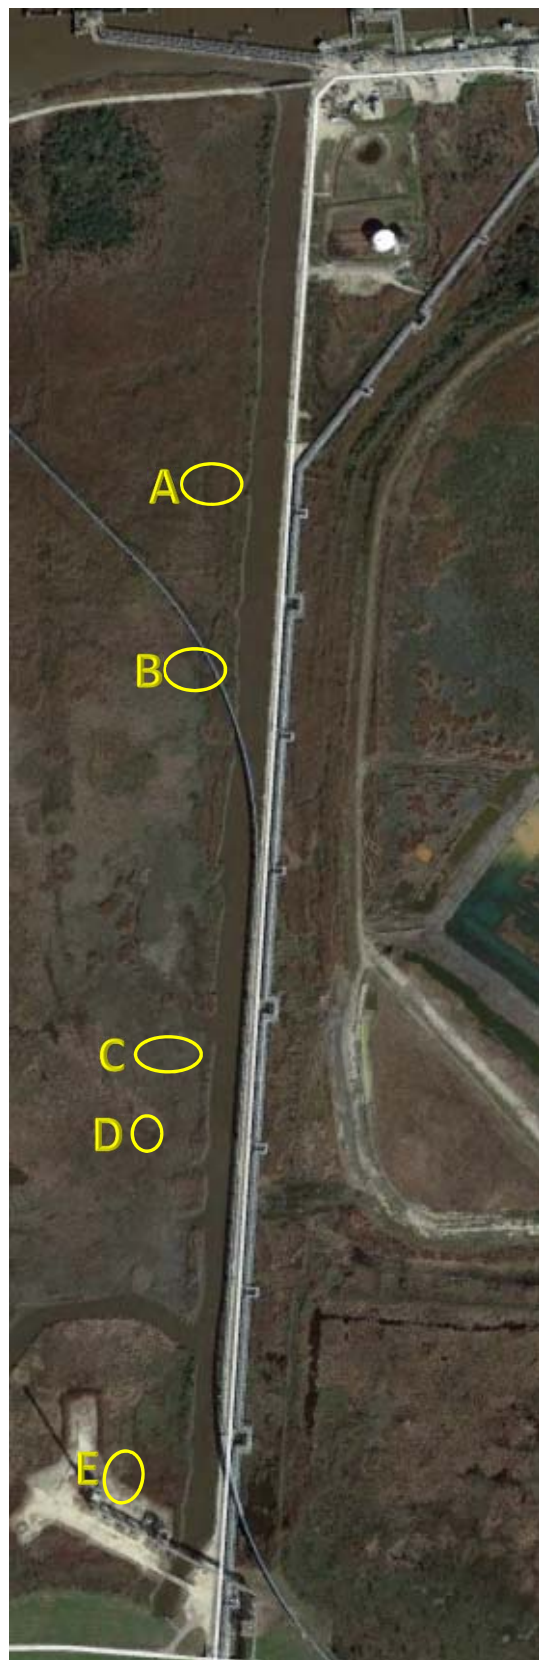
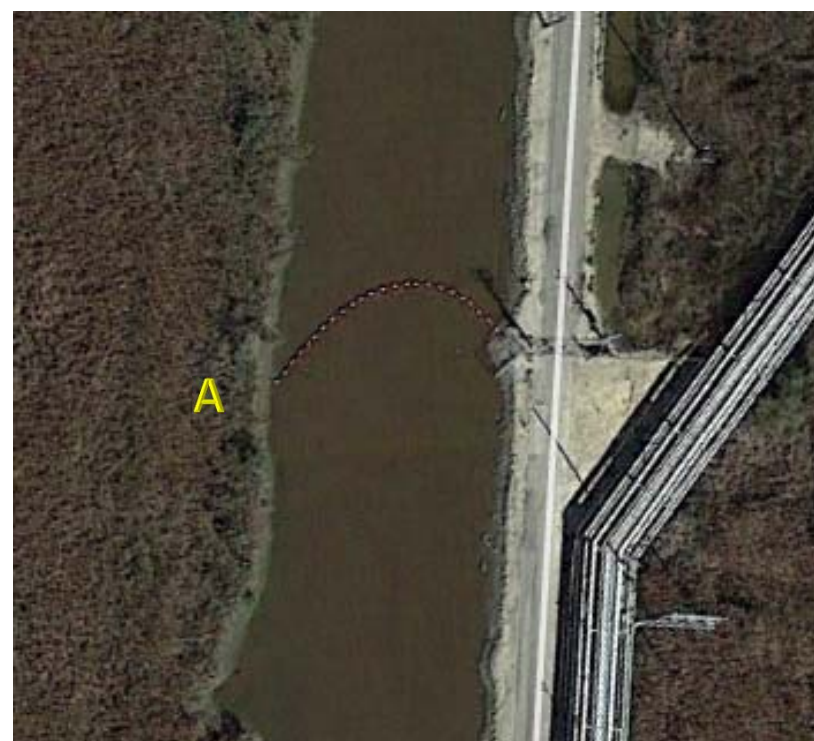
Figure 15: Curvature of Oil Control Booms in the Boat Canal on January 29, 2017

Aerial: January 29, 2017 Google Earth Imagery

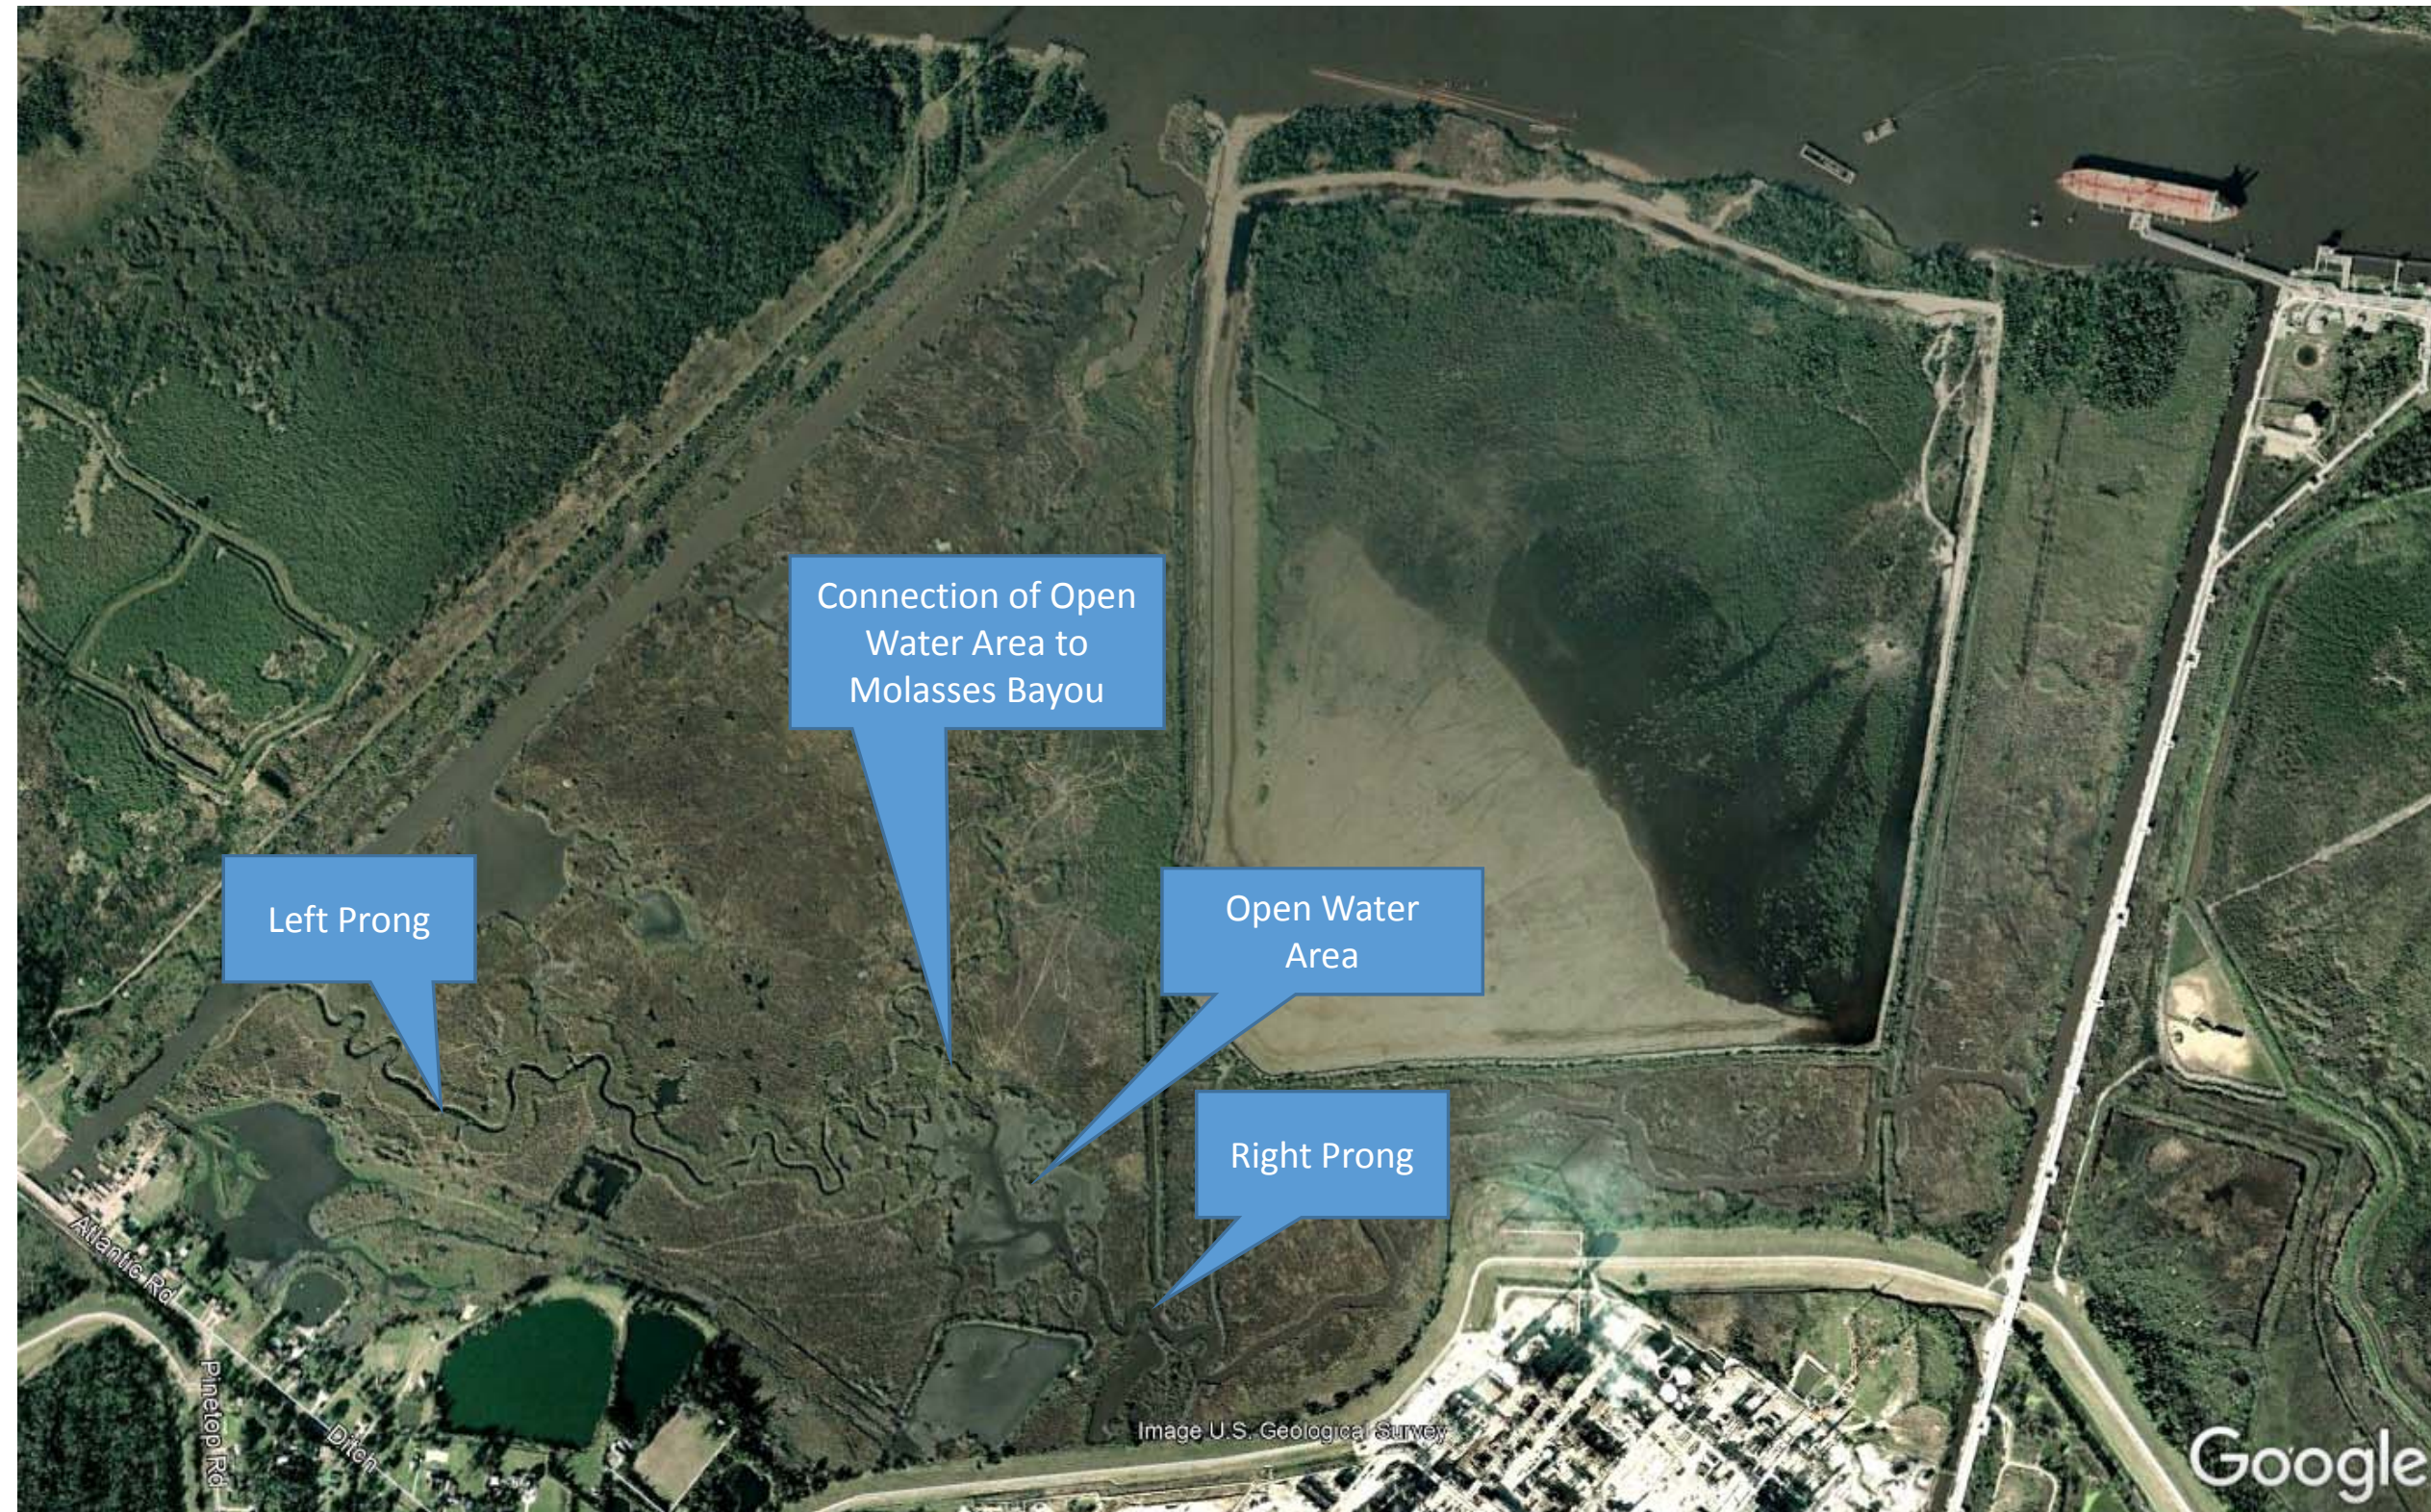
Figure 16: 2006 Aerial Photograph

Aerial: October 31, 2006 Google Earth Imagery

In the copy of the CDM Smith Report received, no photograph is included on the title page for Figure 3-5f. The following discussion is based on our review of the Google Earth October 31, 2006 aerial photograph of the area (attached Figure 16). As noted in the CDM Smith Report, a channel connecting the open water area and the Left Prong is clear in the 2006 imagery. Although this is the first time in the CDM Smith
